HARMONY GROVE VILLAGE SOUTH

Hydromodification Screening Analysis

HYDROMODIFICATION SCREENING FOR

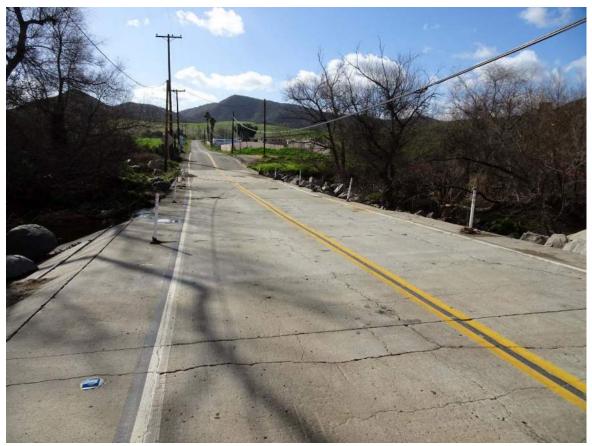
Figure 1. Country Club Drive (Grade Control) at Upper End of POC 1

POC 1 is just downstream of Country Club Drive. The Country Club Drive Arizona crossing is the first grade control point upstream of POC 1. Country Club Drive and its culverts will be replaced with a bridge as part of the project. However, the riprap grade control along Country Club Drive will remain. Since the grade control is immediately upstream of POC 1, the upstream domain of analysis location for POC 1 is at POC 1.

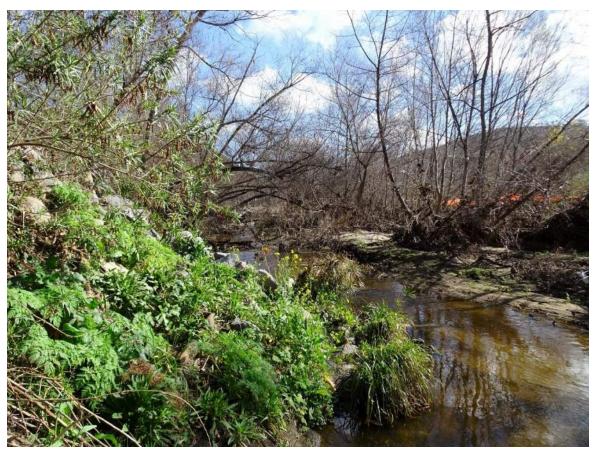
Figure 3. Middle of Reach 1

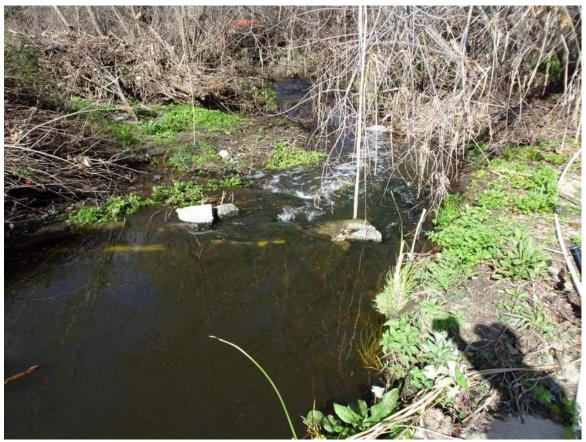
Figure 5. Concrete Grade Control between Reach 1 and Reach 2

Per the first bullet item, the first grade control in Escondido Creek below POC 1 and 2 were located. The runoff from POC 1 outlets directly into Escondido Creek. The channel reach below POC 1 was walked and a concrete grade control was discovered approximately 696 feet downstream (see Figure 5 and the Study Area Exhibit in Appendix A). Natural grade controls were also observed in Escondido Creek created by objects such as fallen tree trunks. However, these were not considered since they can be dynamic. The unnamed natural drainage course below POC 2 was also walked and a rock-lined grade control was observed approximately 190 feet downstream (see Figure 10). Cordrey Drive crosses the unnamed natural drainage course

Based on the above information, the downstream domain of analysis criteria for POC 1 is first met at the concrete grade control. This is the first point reached from the four bullet items. As stated in the first bullet item, the downstream domain of analysis should extend one reach below the grade control. As mentioned above, a reach is based on 20 channel widths, not to exceed 656 feet. The channel top width below the grade control is approximately 50 feet wide, and 20 times this width is 1,000 feet. This distance exceeds a reach, therefore, the downstream domain of analysis location was set at a reach or 656 feet downstream of the concrete grade control (see the Study Area Exhibit in Appendix A).

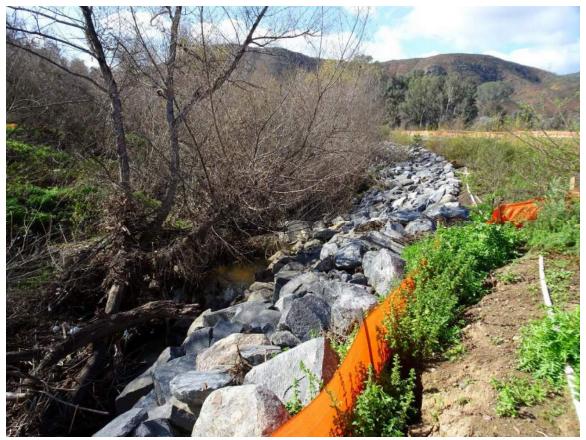
Figure 7. Lower End of Reach 2

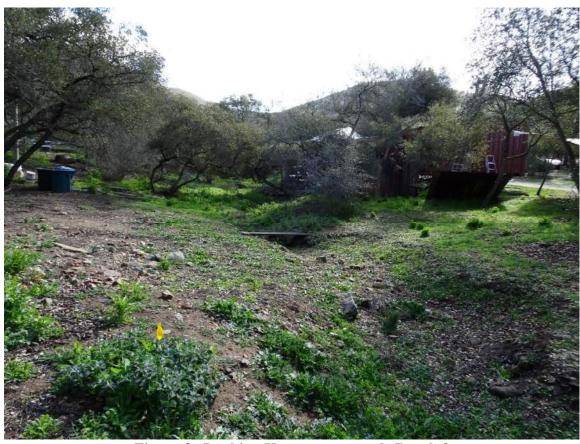
Figure 8. Looking Upstream towards Reach 3

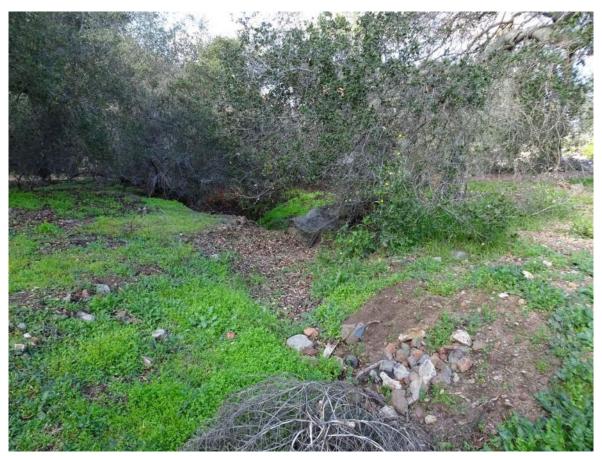
Figure 9. Looking Downstream towards Reach 4

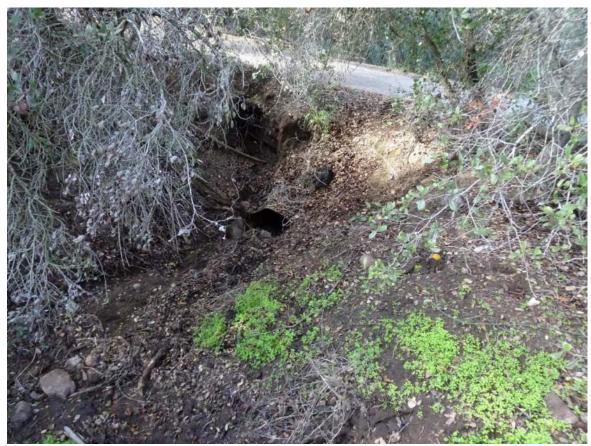
Figure 11. Culvert (Grade Control) under Cordrey Drive at Downstream End of Reach 4

approximately 33 feet below the rock-lined grade control. A culvert conveys flow under Cordrey Drive (see Figure 11). The culvert functions as a grade control.

For POC 2, the downstream domain of analysis criteria is first met at the rock-lined grade control. For this POC, a second grade control occurs 33 feet below the rock-lined grade control, i.e., the second grade control is at the Cordrey Drive culvert. Therefore, the downstream domain of analysis location was set at the entrance to the Cordrey Drive culvert.

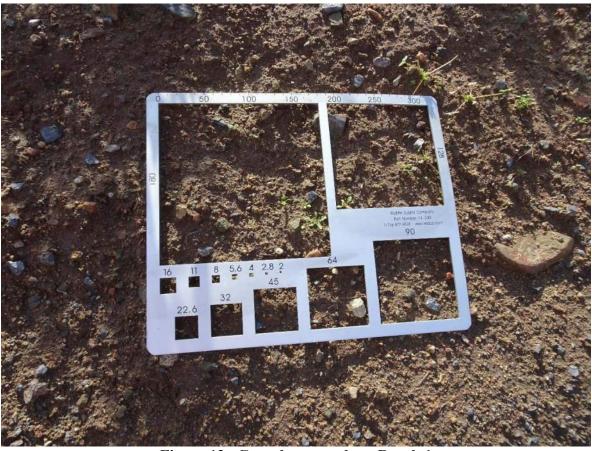
Figure 12. Gravelometer along Reach 1

The d_{50} value is the particle size in which 50 percent of the particles are smaller and 50 percent are larger. The pebble count results for each study reach are included in Appendix B and summarized in Table 3. The screening index values (INDEX) for the four reaches are tabulated on Form 1 in Appendix A and also included in Table 3. The Screening Index Threshold diagram (Checklist 3) in Appendix B provides 50% Risk values for various d_{50} values. These values are included in the last column of Table 3. If the INDEX value is less than the 50% Risk value, the reach has less than 50 percent probability of incising and falls within Category A. Table 2 shows that this is the case for all four study reaches.

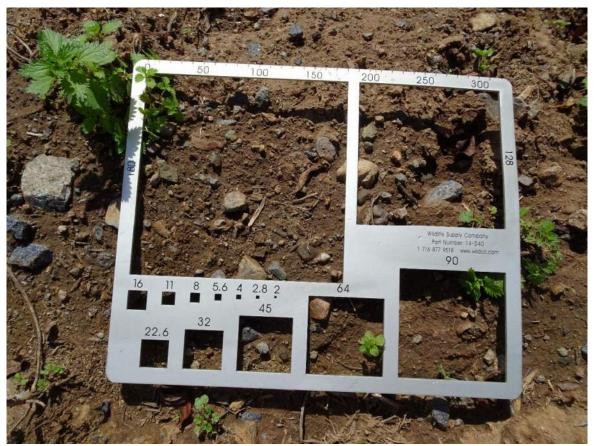
Figure 13. Gravelometer along Reach 2

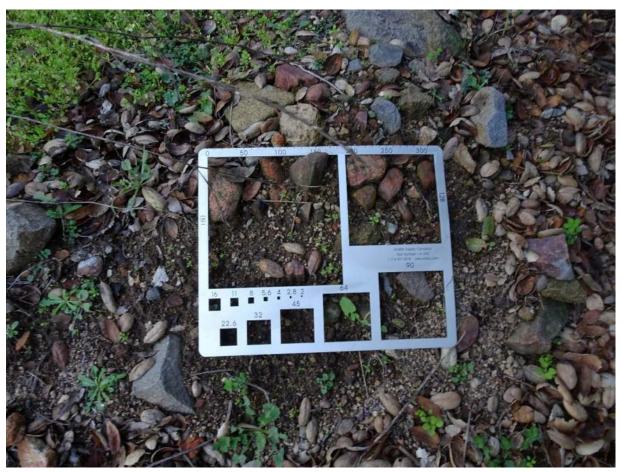
Figure 15. Gravelometer along Reach 4
